The Bayswater Covered Bridge Restoration

Background/History

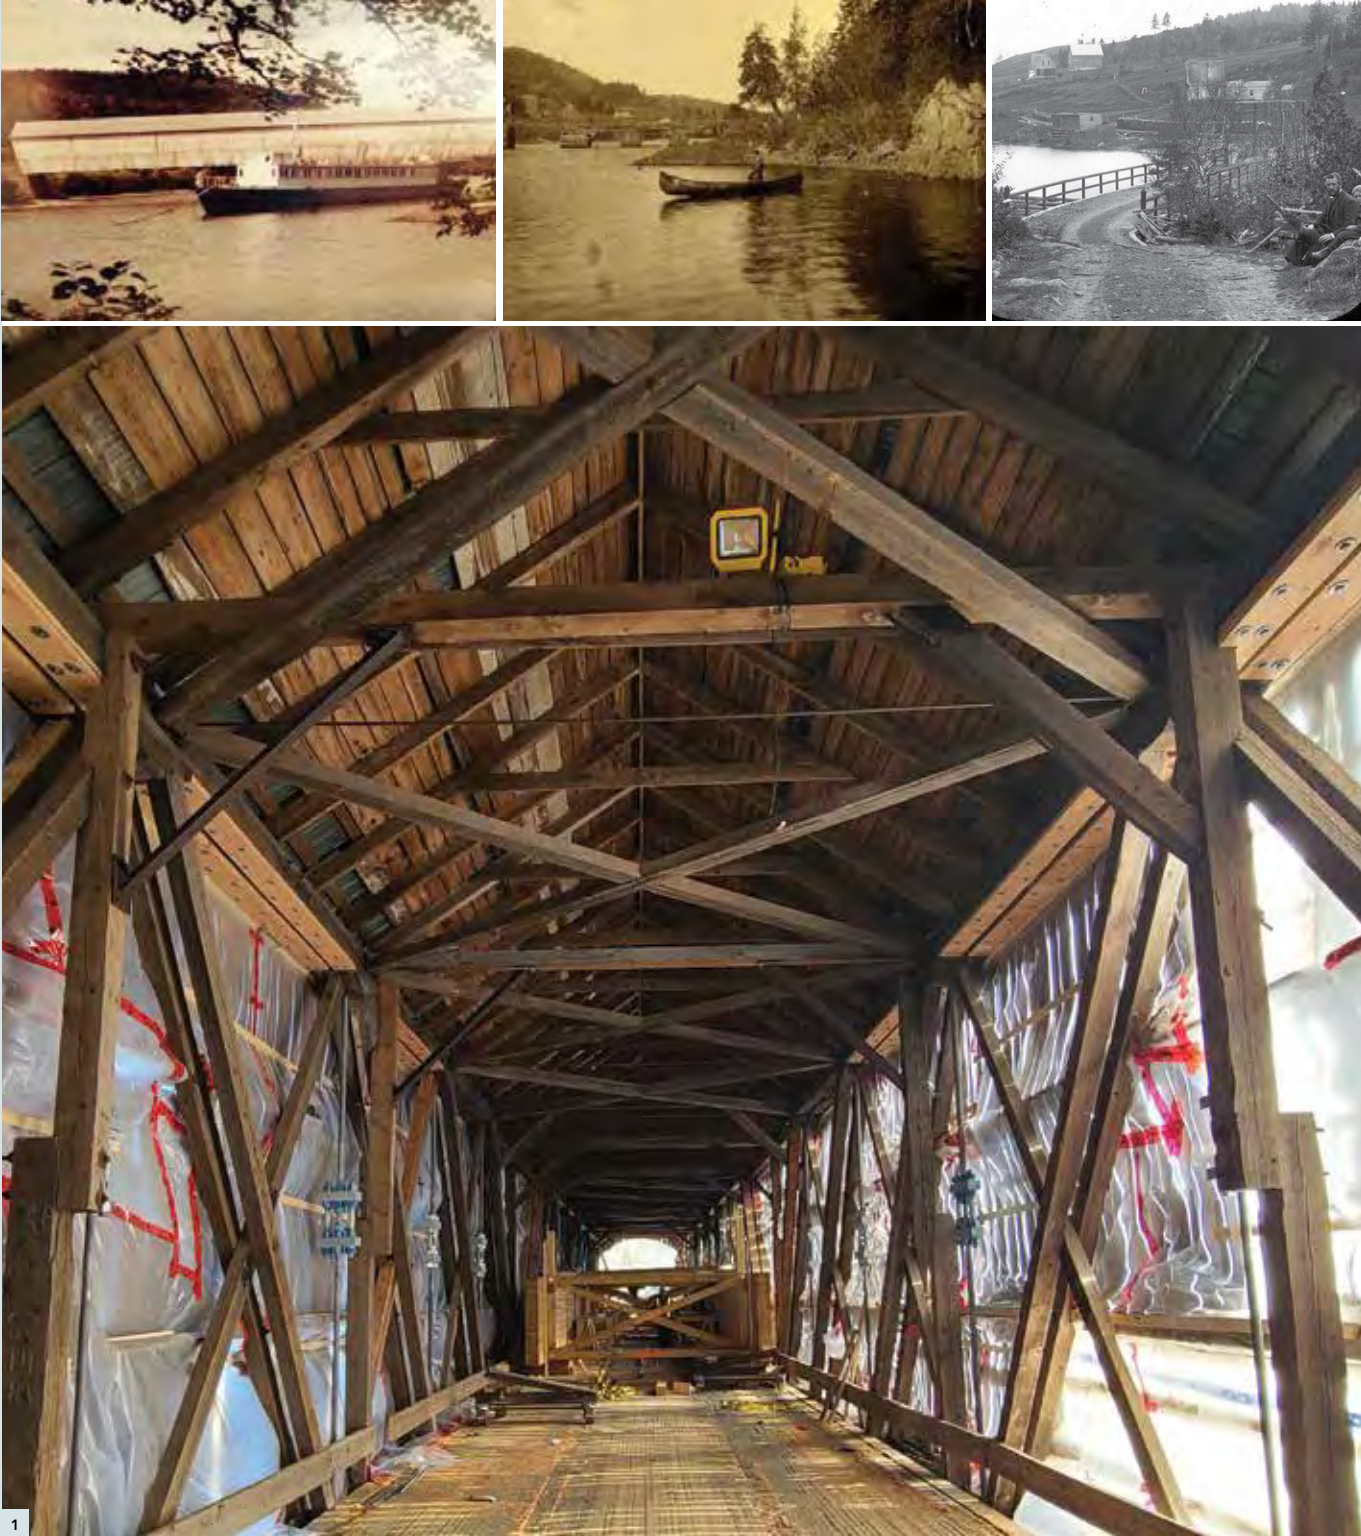
1. The bridge in the early stages of repair. New longitudinal glulam decking would be installed to replace the original nail-laminated system.

- New longitudinal glulam decking was installed over the floor beams to replace the original nail-laminated system.

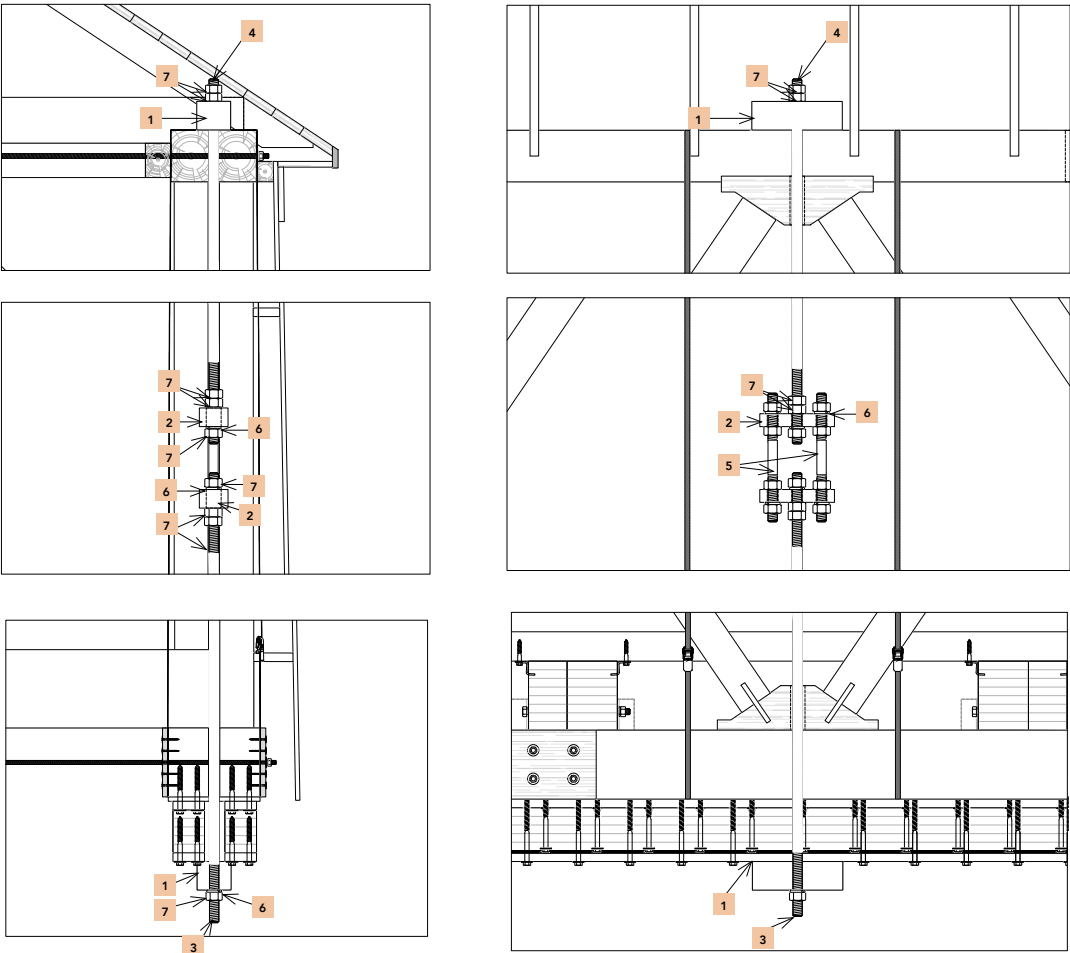
Vertical steel rod connection

2. Splice detail of the vertical steel tension rods. See drawing far right.

- All tension rods were replaced with new galvanized elements. Steel considerations for fatigue, torque and fracture control were assessed when sizing and determining steel grade. In addition, due to the roof on the bridge structure, the rods had to be replaced in two halves, requiring a tension splice in the rods.

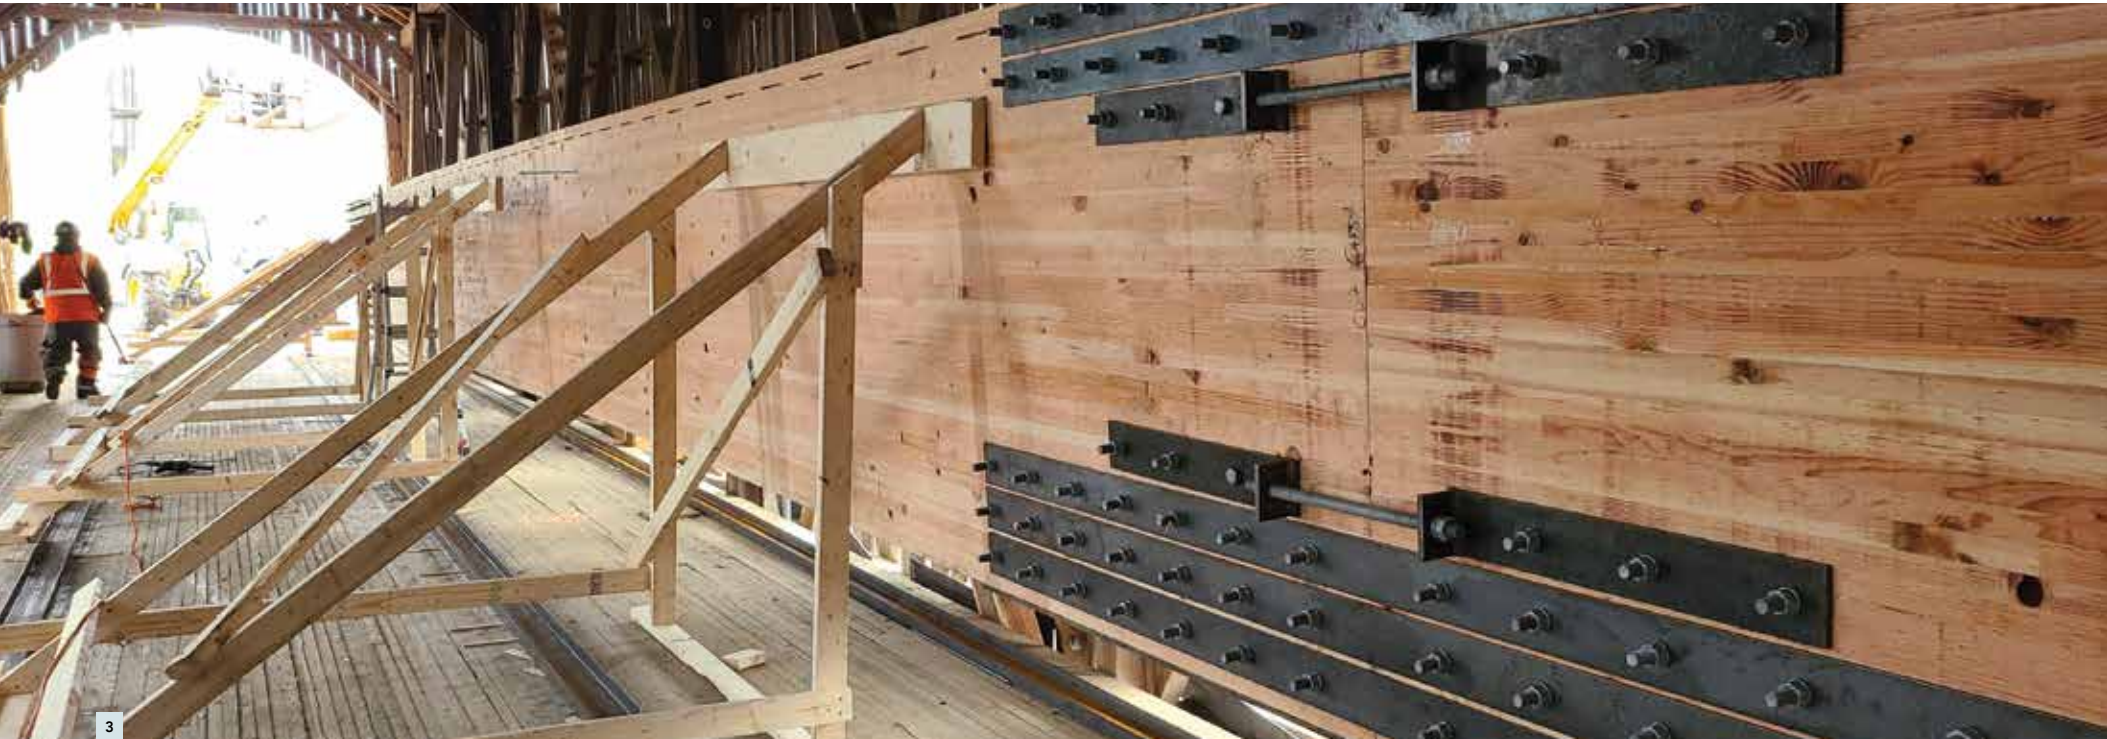
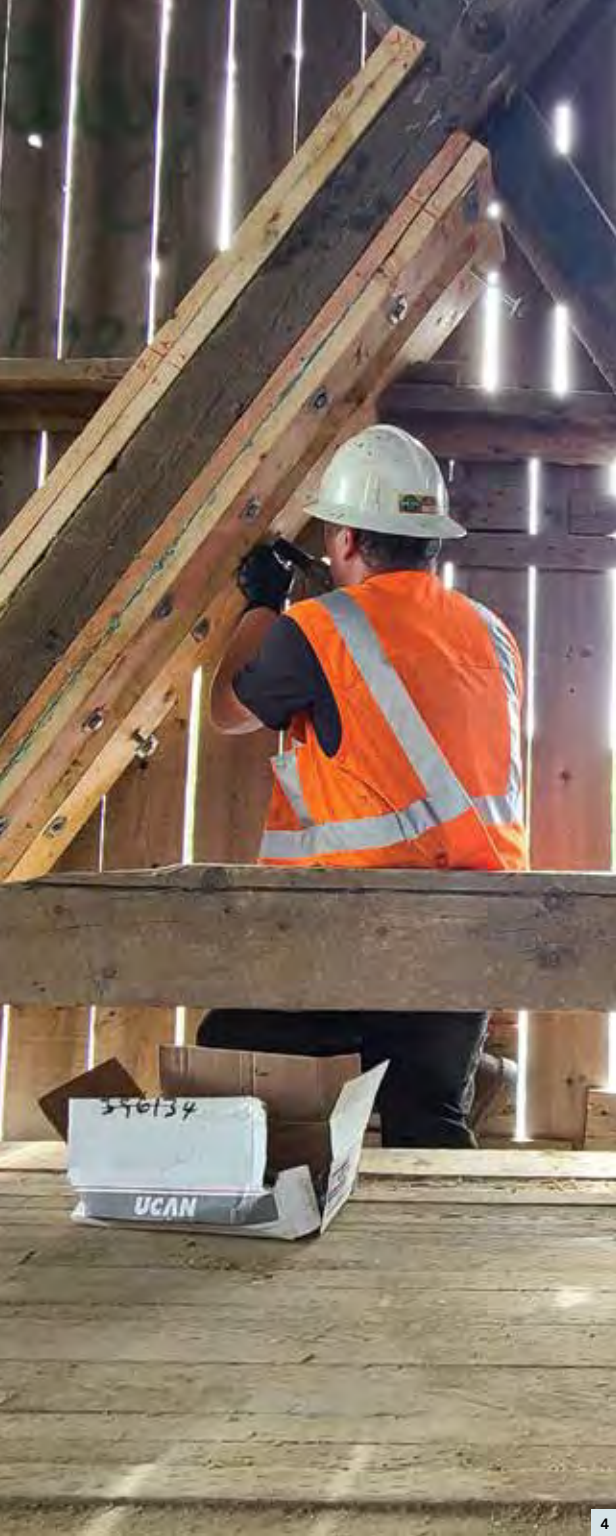
4. Compression reinforcement using high-strength timber laminations (Retrocom) were adhered to the web elements and compression chord elements in areas with decay or which required additional load capacity.

- Various compression elements were reinforced using Retrocom products to increase capacity in areas of degradation.

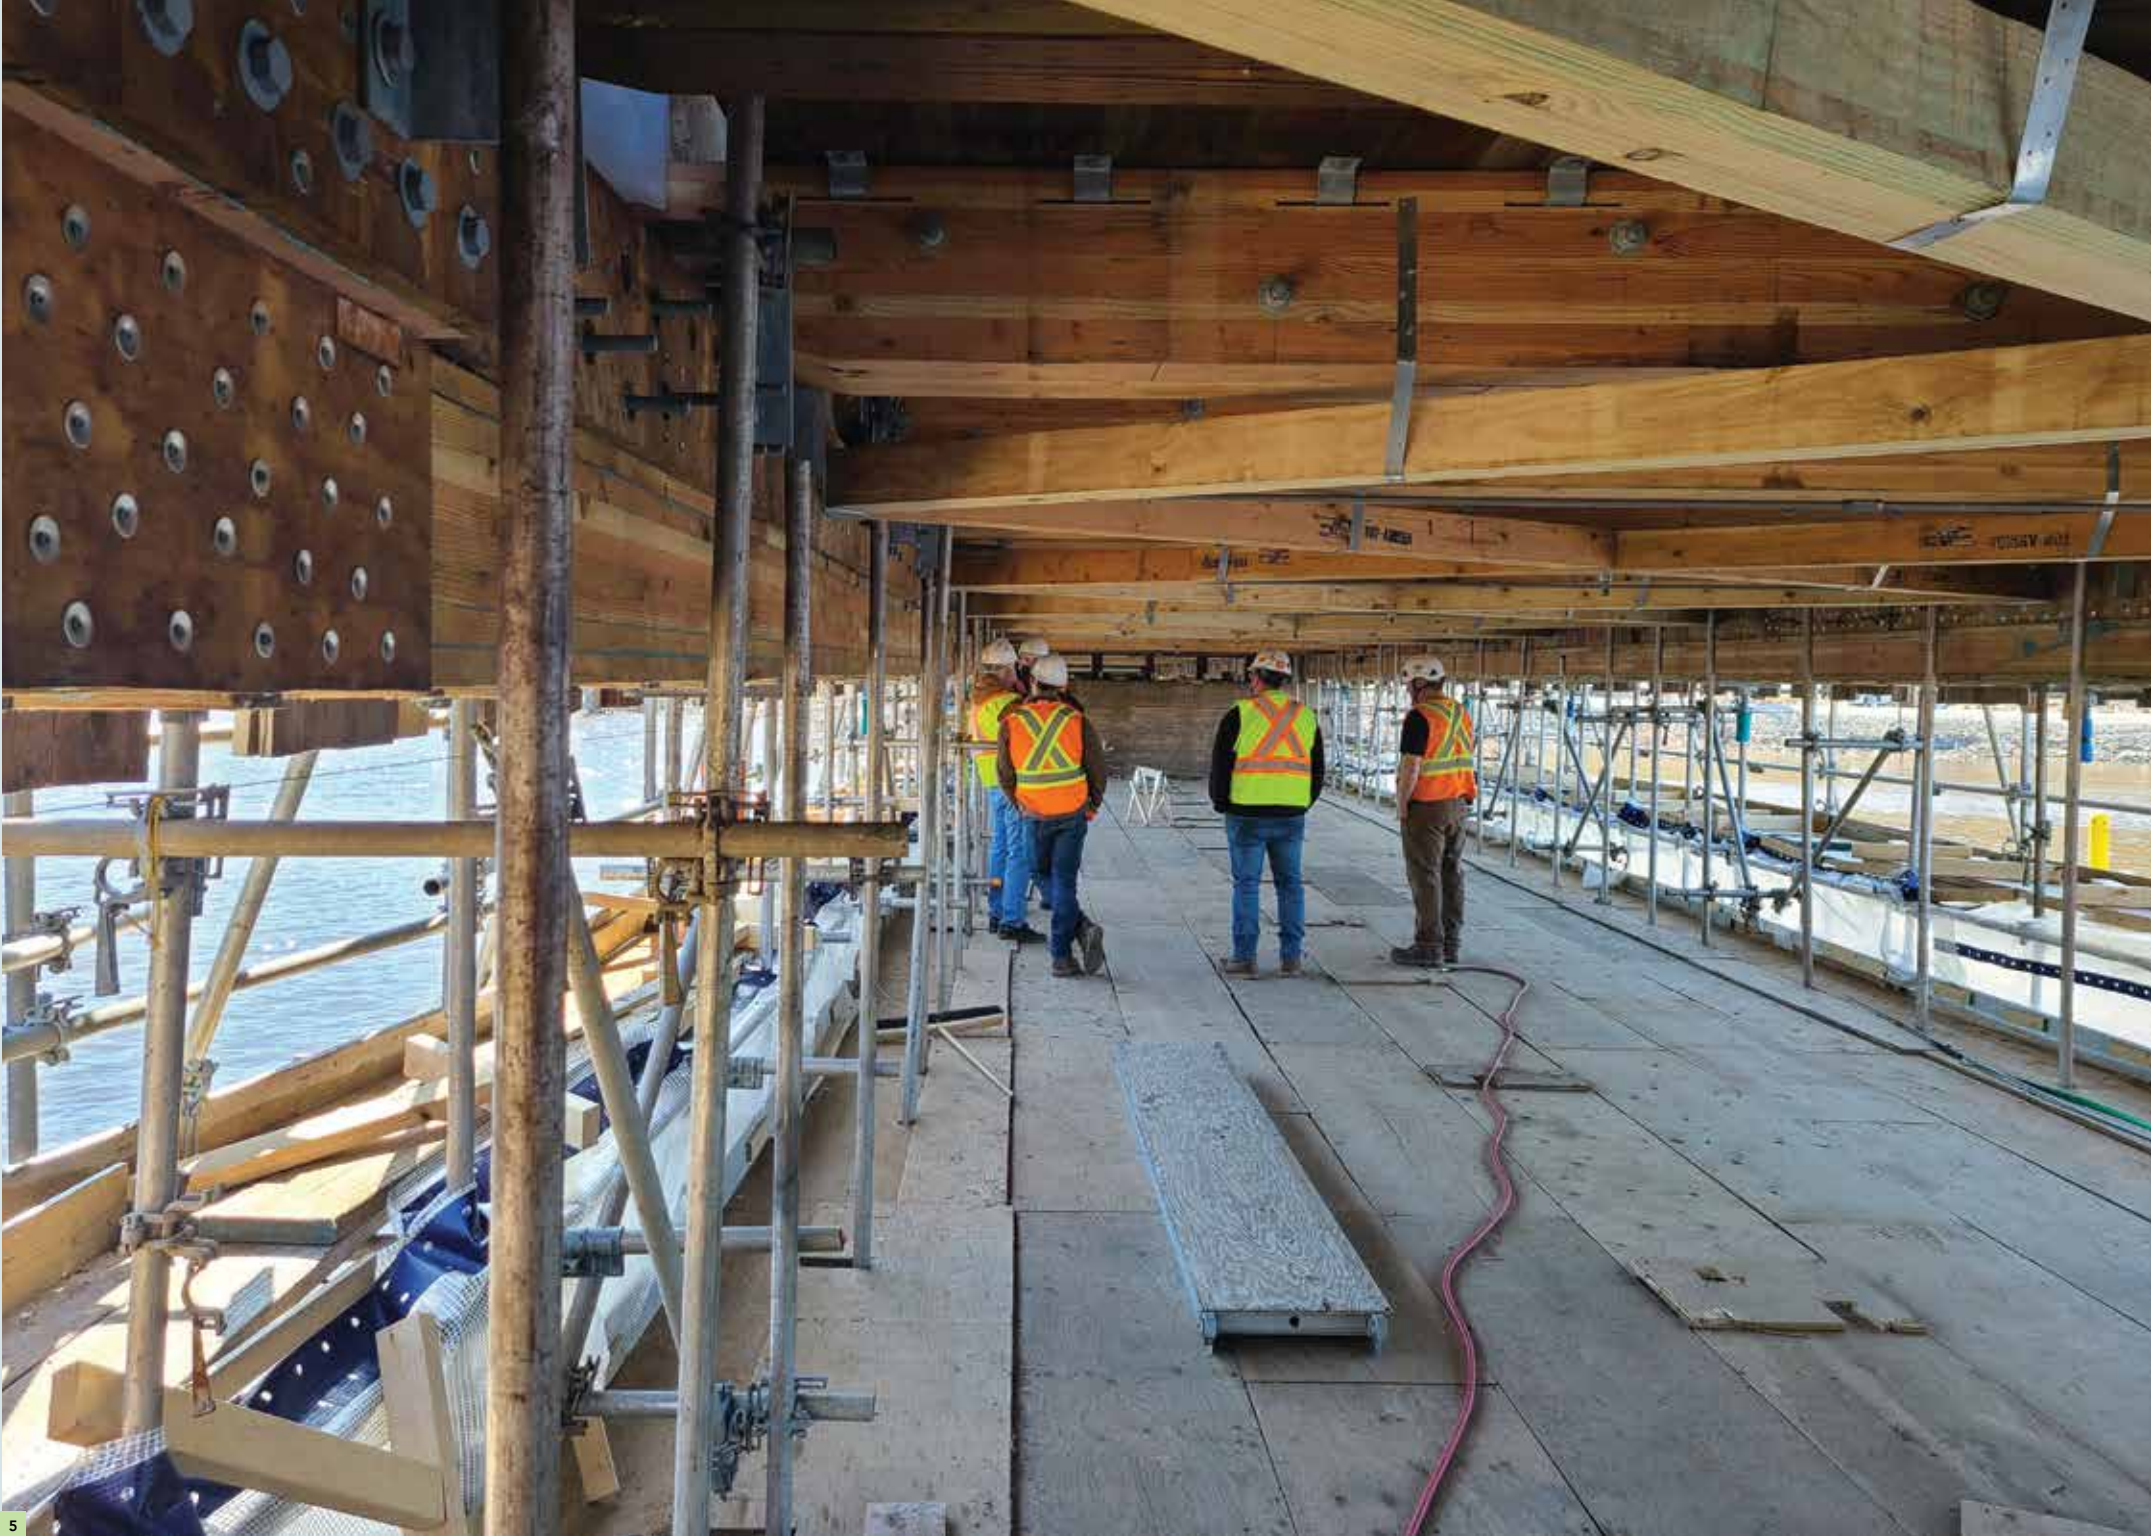
5. The existing floor beams were replaced with new glulam beams and installed as close to the truss nodes as possible. The elements were shifted to reduce bending and shear forces within the tension chord.
6. An overview of the girder lift system, which was designed by WRD, and built by Timber Restoration Services. The lifting system was removed after the Span 2 camber reinstatement and related works were completed. This view showcases the proportions of the lift beams to the current structure.

- New floor beams were installed and moved as close to the truss nodes as possible. This limited the amount of bending and shear forces within the chord. However, not all of these forces could be mitigated due to interference with the web elements.

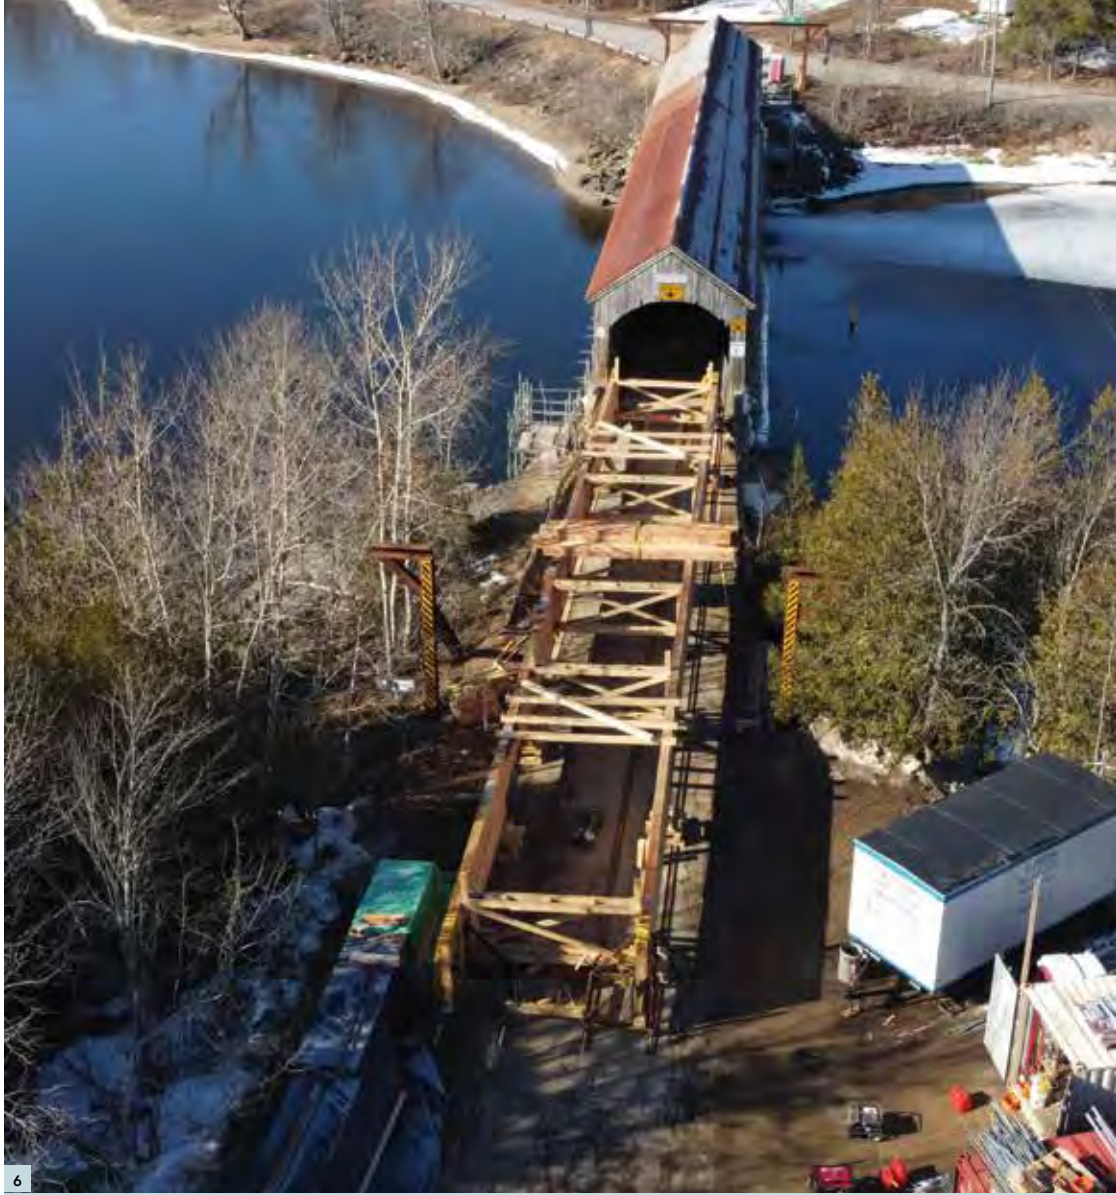
3. To support the bridge during construction, two glulam high strength fibre beams were rolled onto each span. The elements were light weight enough to maintain the current bridge posting for installation (5 tonnes), as well as contained sufficient strength to lift the bridge.

- Over the years, due to a sag in the bridge, the steel tendon post-tensioning (hawg jaw) system had become engaged. The repairs to the tension chord could not safely occur without the removal of this system. As such, the structure was lifted and supported by two fibre-reinforced glulam beams. Due to the weight restriction on the bridge, the lifting system was largely limited. Luckily, the glulam elements, in conjunction with the high-strength fibre, met this weight requirement. The lift girders were rolled through the bridge on a steel track and put in place one by one. Each span was lifted individually. The bridge was successfully lifted and the load within the hawg jaw was removed. This allowed for the safe removal of the system as well as the reinstatement of camber.

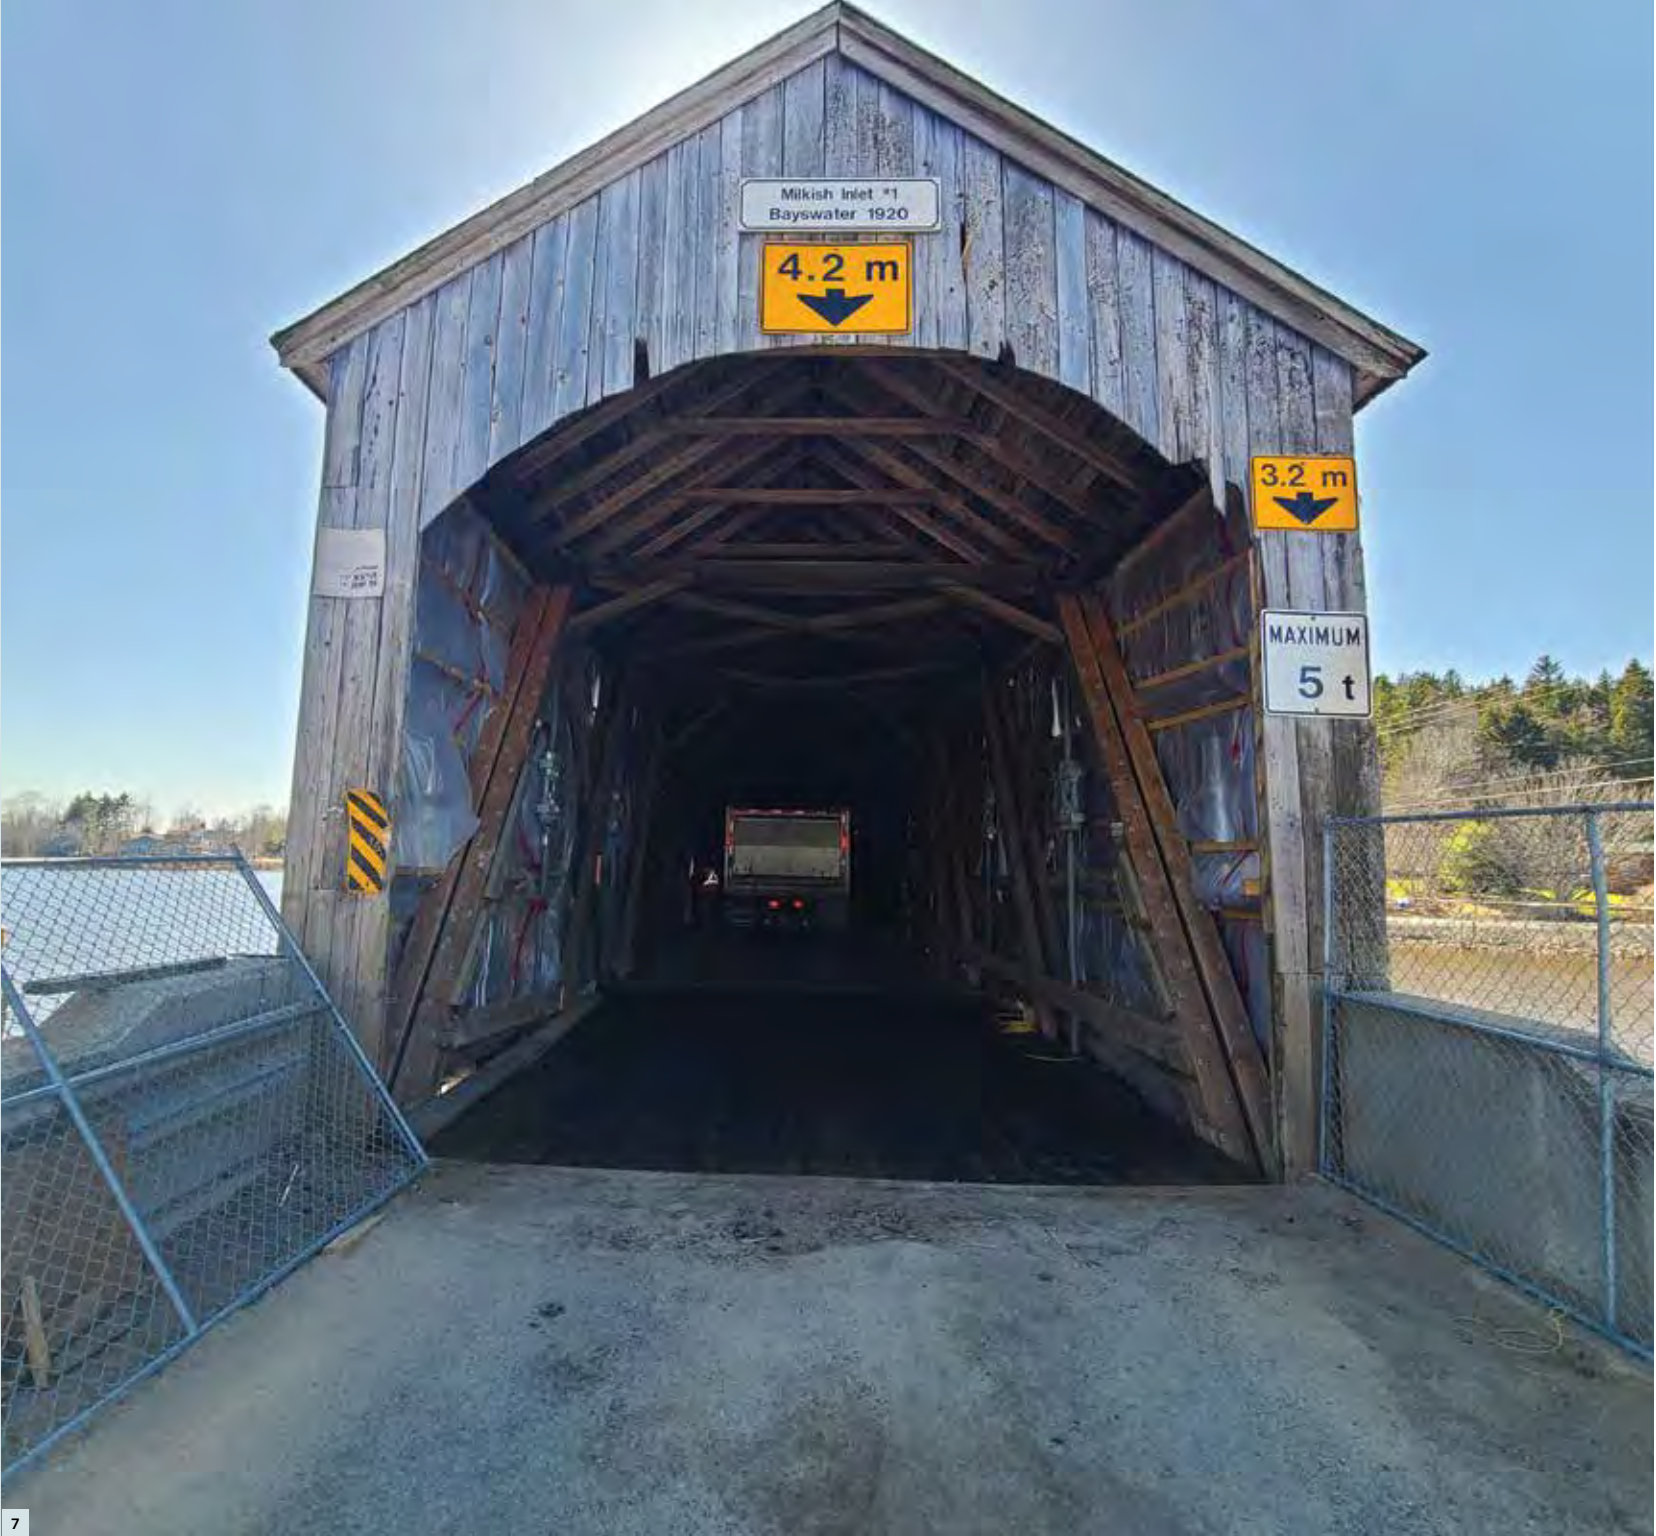
7

7. The bridge undergoing load testing. As part of the rehabilitation some of the timbers contain borate salt rods which create a brine solution to neutralize pH and prevent decay.
