The Bayswater Covered Bridge Restoration

Background/History

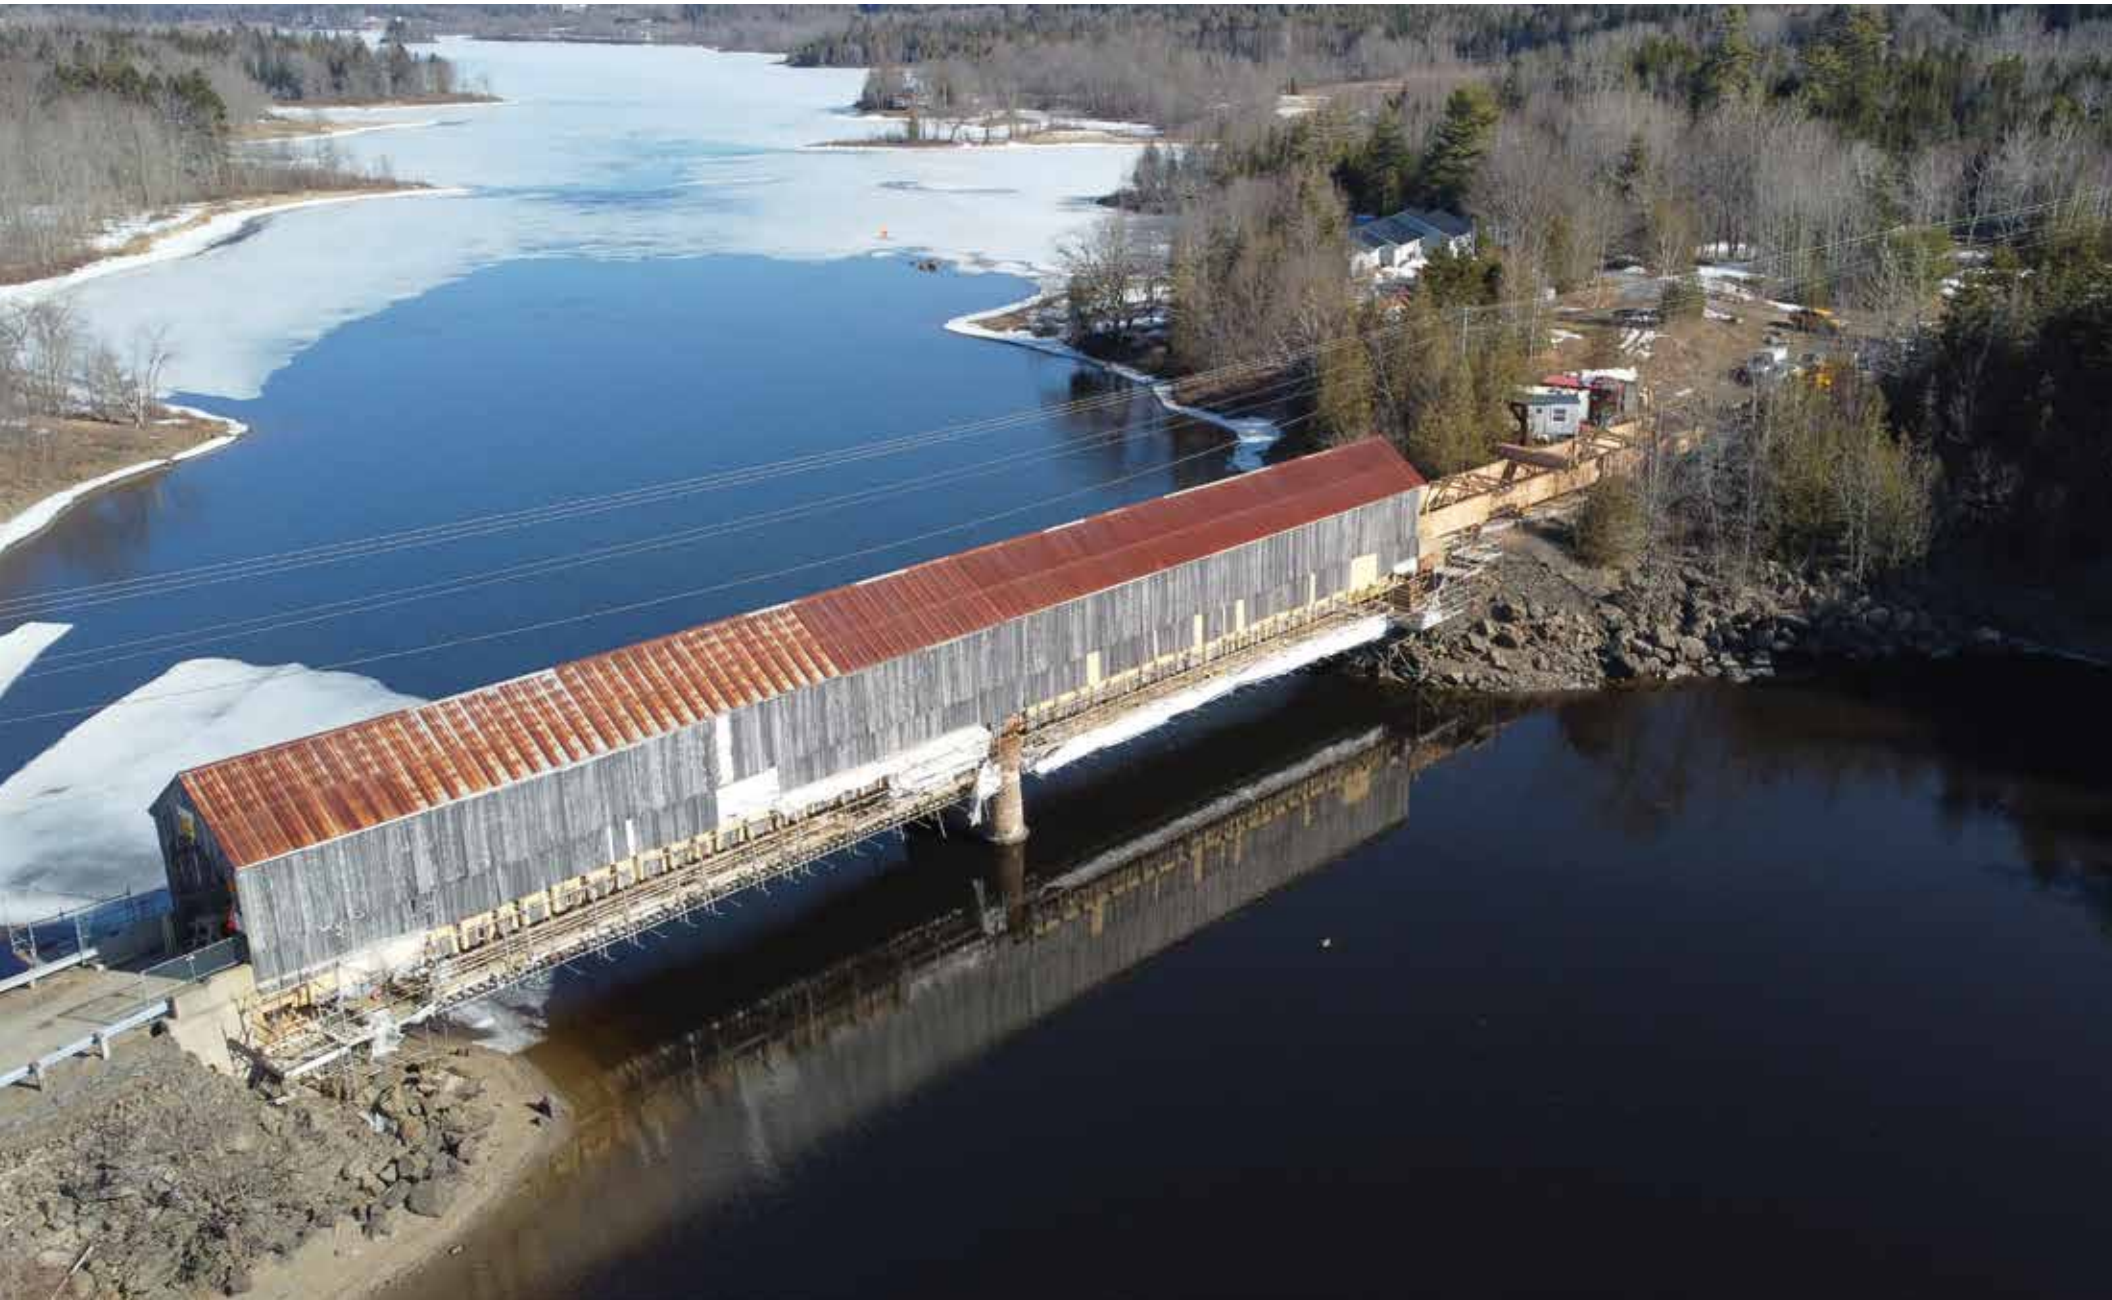
1. The bridge in the early stages of repair. New longitudinal glulam decking would be installed to replace the original nail-laminated system.

- New longitudinal glulam decking was installed over the floor beams to replace the original nail-laminated system.

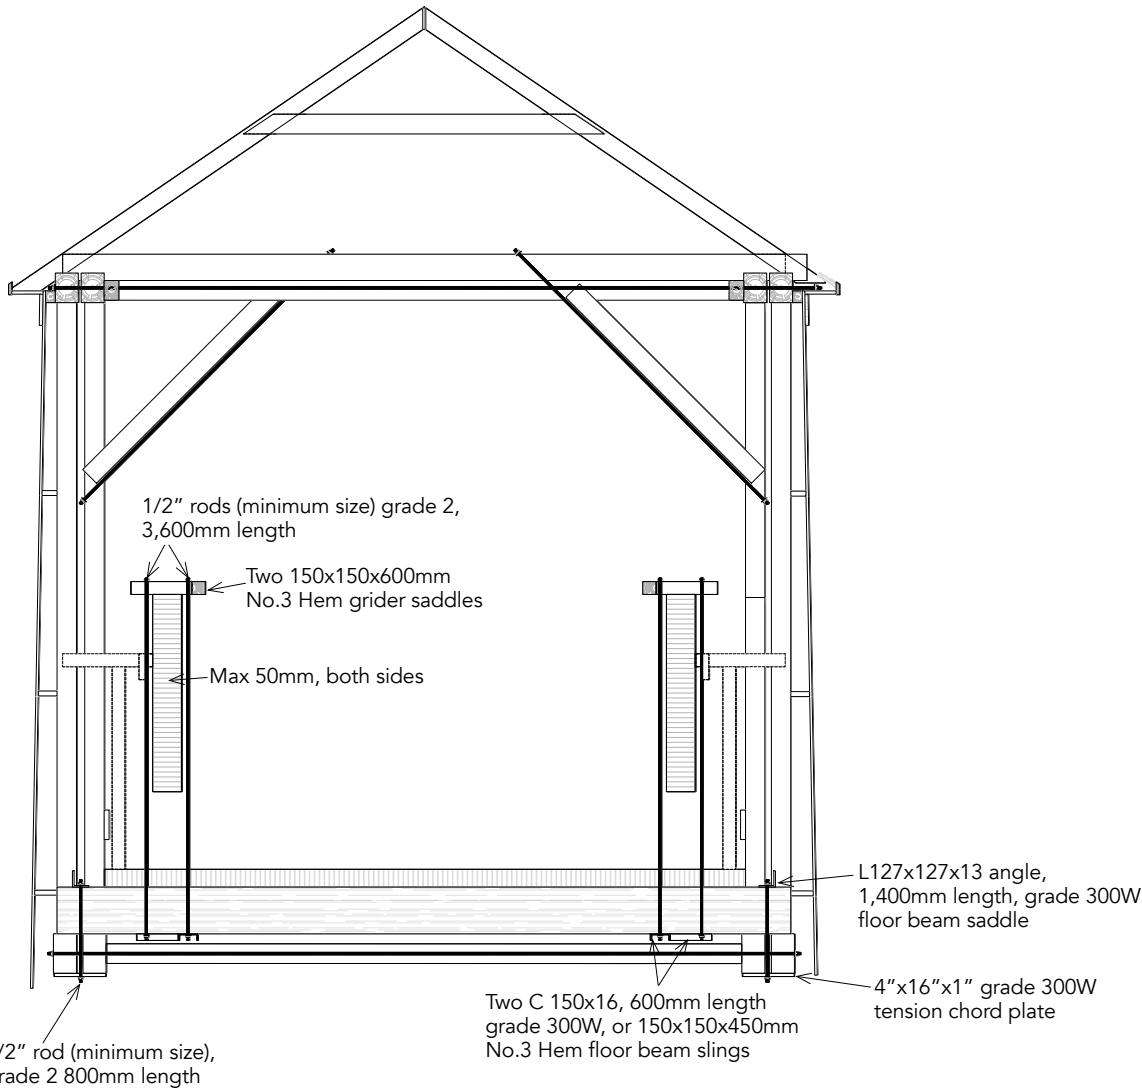
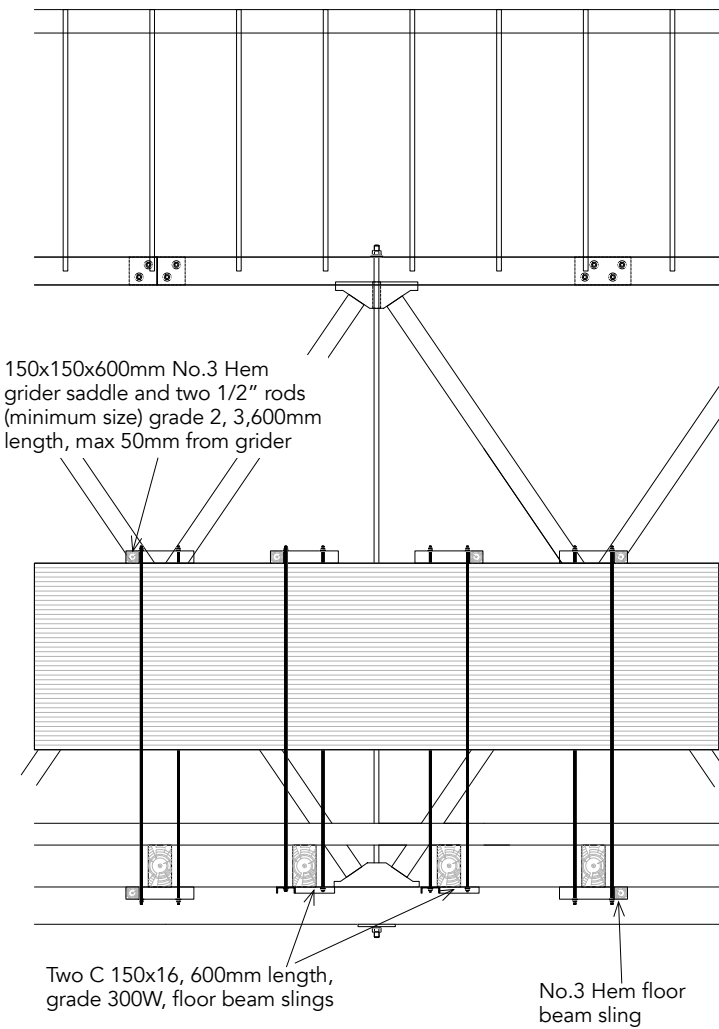
Section through a bay during the lifting process

- Over the years, due to a sag in the bridge, the steel tendon post-tensioning (hawg jaw) system had become engaged. The repairs to the tension chord could not safely occur without the removal of this system. As such, the structure was lifted and supported by two fibre-reinforced glulam beams. Due to the weight restriction on the bridge, the lifting system was largely limited. Luckily, the glulam elements, in conjunction with the high-strength fibre, met this weight requirement. The lift girders were rolled through the bridge on a steel track and put in place one by one. Each span was lifted individually. The bridge was successfully lifted and the load within the hawg jaw was removed. This allowed for the safe removal of the system as well as the reinstatement of camber.

Several of these items required temporary support during construction, to ensure elements or bolts could be safely removed while the structure remained stable. Many of the elements that underwent high-strength replacement occurred during the bridge lift, where two glulam high strength fibre beams were used to lift the bottom chord, release the tension in the hawg jaw system (allowing for its safe removal) and reinstate camber in the truss.

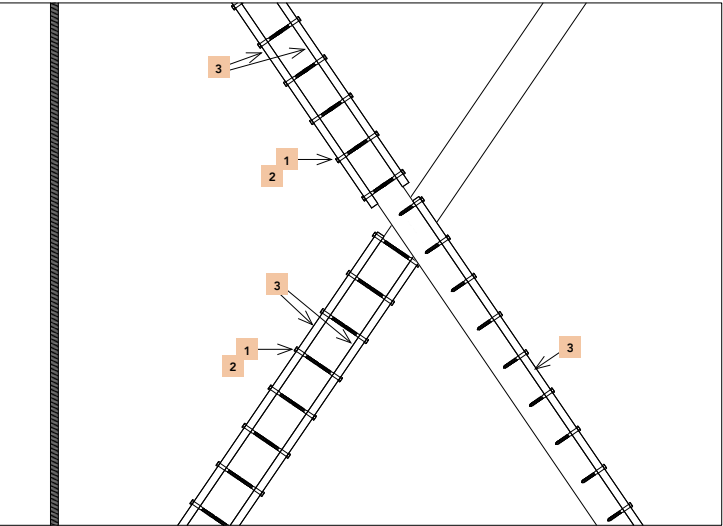
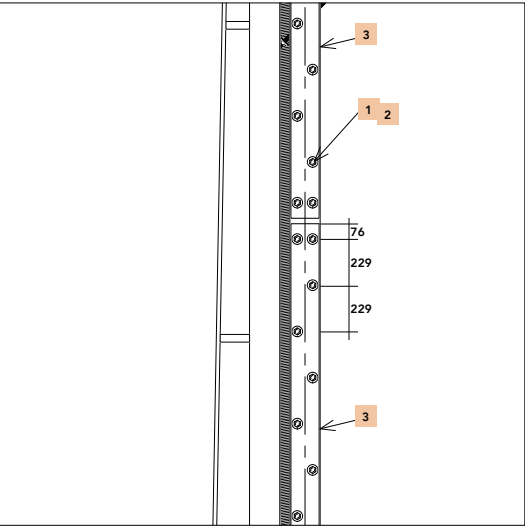
Section through Retrocom detail

4. Compression reinforcement using high-strength timber laminations (Retrocom) were adhered to the web elements and compression chord elements in areas with decay or which required additional load capacity.

- Various compression elements were reinforced using Retrocom products to increase capacity in areas of degradation.
